# Service Bulletin

20-036

## **Rattling from the Front of the Vehicle**

Year	Model	Trim	VIN Range
2018-20	Accord	ALL	ALL
2018-20	Accord Hybrid	ALL	ALL

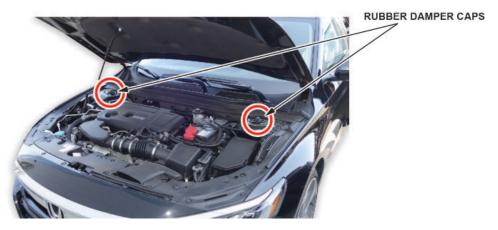
RUBBER DAMPER CAPS

The rubber damper cap(s) are faulty.

Remove the rubber damper caps, then test-drive the vehicle.

- If you no longer hear a rattling from the front of the vehicle with the caps removed, go to REPAIR PROCEDURE.
- If you still hear a rattling from the front of the vehicle with the caps removed, this bulletin does not apply. Continue with normal system troubleshooting.
